Date: December 2017/
January 2018

GM 6T40* Drum Saver

Drivetech has your solution to 3-5-R Drum wear caused by a broken 3-5-R Wave Spring with our new Drum Saver Kit.

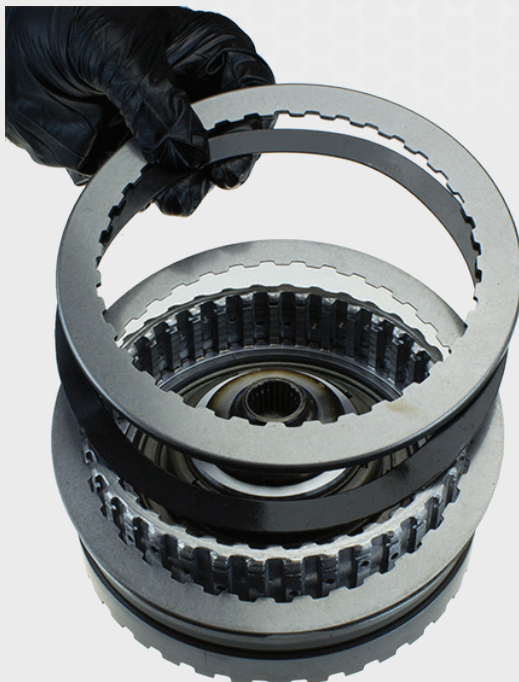
Breakage of the 3-5-R wave spring is a common fault with the 6T40 transmission and continued operation after wave spring failure can result in damage to the 4-5-6/3-5-R drum at the 3-5-R clutch hub area. The 3-5-R piston can also wear at the hemline area where the piston contacts the wave spring.

With damage

Drivetech now have available a specifically designed kit to allow reuse of the drum where the hub has sustained typical damage to the lower spline area. Use of this kit offers a cost saving compared to replacing the drum assembly.

- **Part Number: JXK-640035**

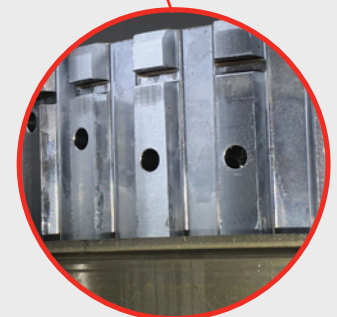
Without damage
